# WELDING INSPECTION REPORT

Resident Engineer: Pursell, Gary **Report No:** WIR-011920 Address: 333 Burma Road **Date Inspected:** 07-Feb-2010

**OSM Arrival Time:** 700 **Project Name:** SAS Superstructure **OSM Departure Time:** 1900 **Prime Contractor:** American Bridge/Fluor Enterprises, a JV

34-0006 **Bridge No: Component:** Tower

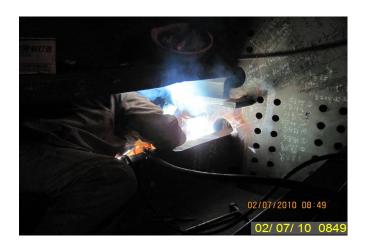
1. This QA inspector, Baskar Govindarajan, observed, ZPMC qualified welding personnel identified as 040434 perform FCAW welding on, Skin A fit lug at 143 mtr. Elevation on South tower, Lift 4, and weld joint identified as SSTL4-1K/L-100. ZPMC CWI Identified as Mr. Li lin. The welding parameters as measured using QC's calibrated instruments appeared to be in general compliance with WPS-B-T-2333-TC-P4-F.(Photo attached)

4. This QA inspector, Baskar Govindarajan, observed, ZPMC qualified welding personnel identified as 041716 perform SAW welding on, Spare strut splice plate, and weld joint identified as ED1-SA4-131m-81B. ZPMC CWI Identified as Mr. Yu dong ping. The welding parameters as measured using QC's calibrated instruments appeared to be in general compliance with WPS-B-T-3221-TC-U5-S-1. (Photo attached)
